**LETTER REPORT
FOR
EGAN-MARINE SITE
LEMONT, COOK COUNTY, ILLINOIS
TDD No.: T05-9501-003
PAN: EIL0852CBA**

MARCH 22, 1995

**Prepared for:
UNITED STATES ENVIRONMENTAL PROTECTION AGENCY
Emergency and Enforcement Response Branch
77 West Jackson Boulevard
Chicago, Illinois 60604**

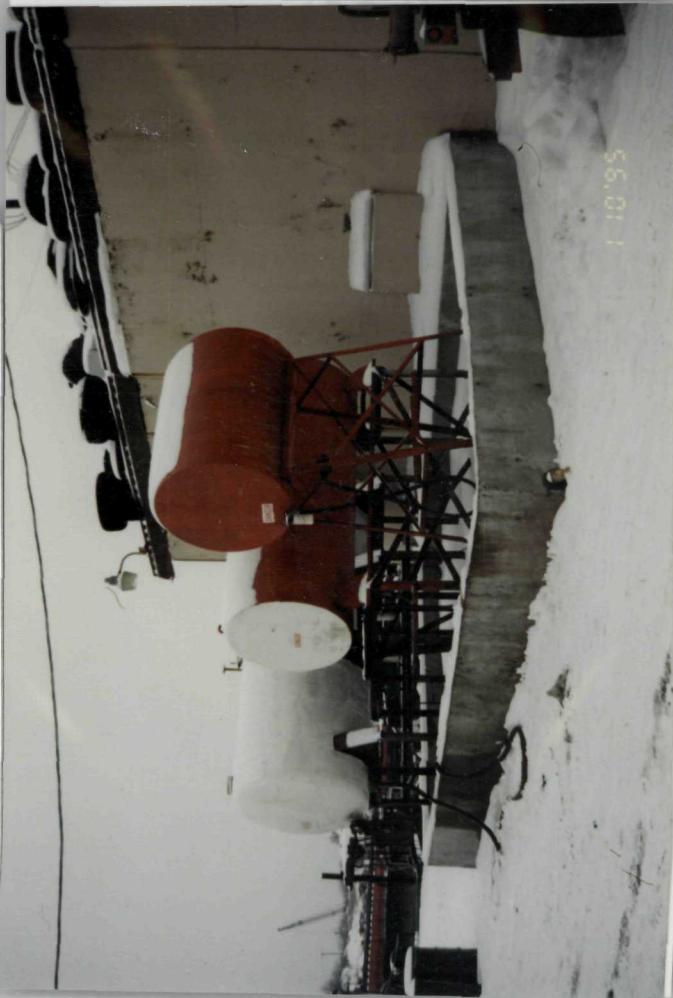
SITE: Egan Marine TDD #: T05-9501-003 DATE: 1/10/95
 PHOTO #: 1 DIR: SE PHOTOGRAPHER: Rydzewski
 DESCR: Diesel fuel tanks which have been moved and
 enclosed in a dike since 10/30/94.

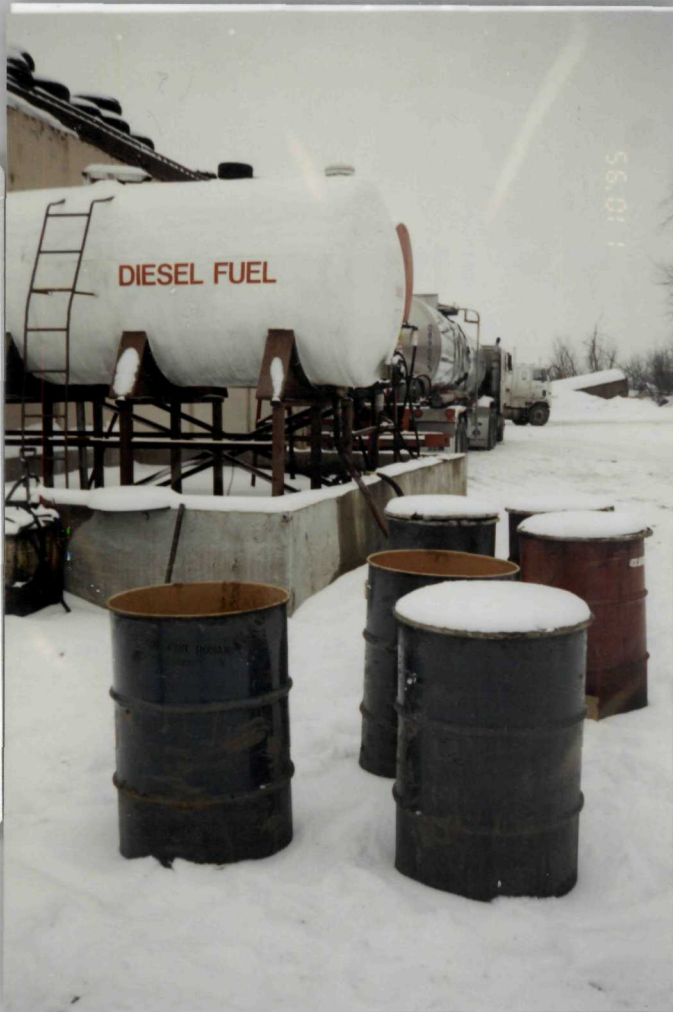
SITE: Egan Marine TDD #: T05-9501-003 DATE: 1/10/95
 PHOTO #: 2 DIR: NW PHOTOGRAPHER: Rydzewski
 DESCR: Drums outside diesel tank berm, filled with
 residual oil from a vacuum truck bought by
 Egan Marine.

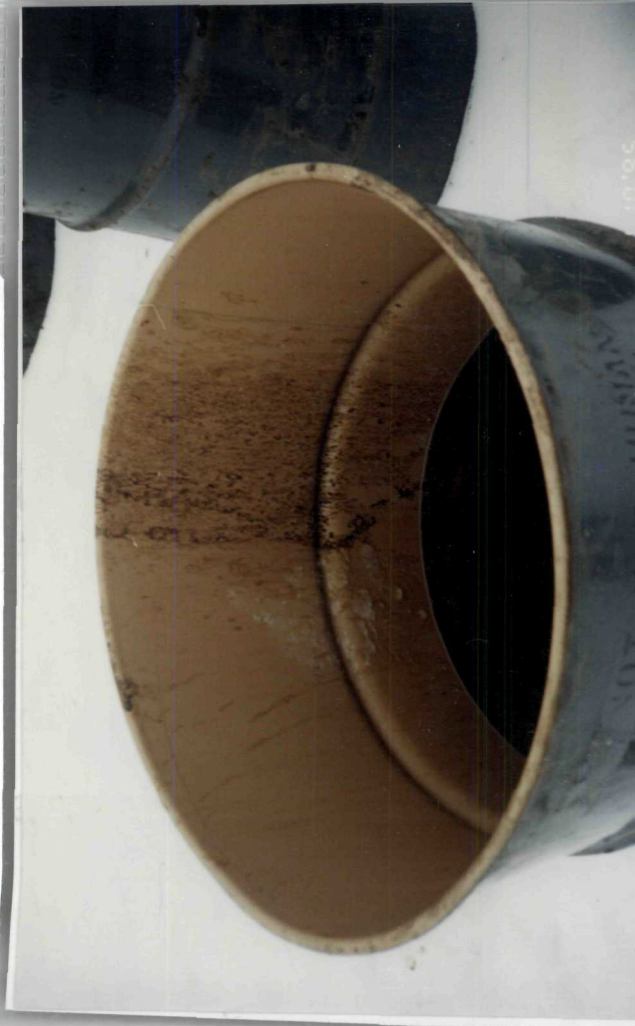
SITE: Egan Marine TDD #: T05-9501-003 DATE: 1/10/95
 PHOTO #: 3 DIR: W PHOTOGRAPHER: Rydzewski
 DESCR: Residual oil in open-top drums near diesel
 tanks. Residual oil is from a vacuum truck.

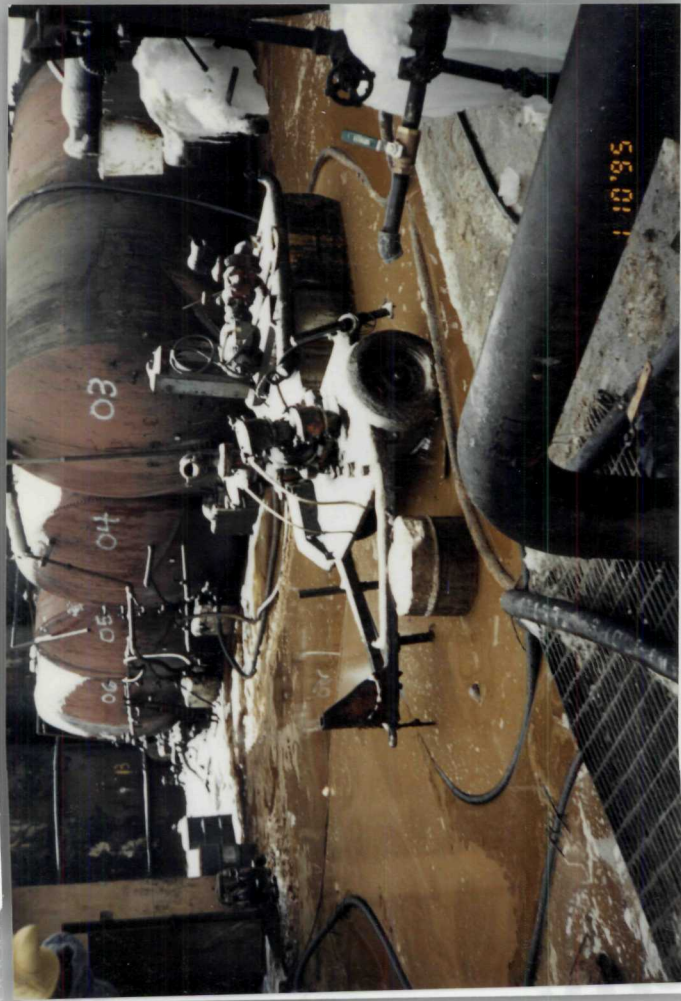
SITE: Egan Marine TDD #: T05-9501-003 DATE: 1/10/95
 PHOTO #: 6 DIR: SW PHOTOGRAPHER: Rydzewski
 DESCR: All oil from the shallow pit drains to this sump. Water/oil is then pumped out to canal.

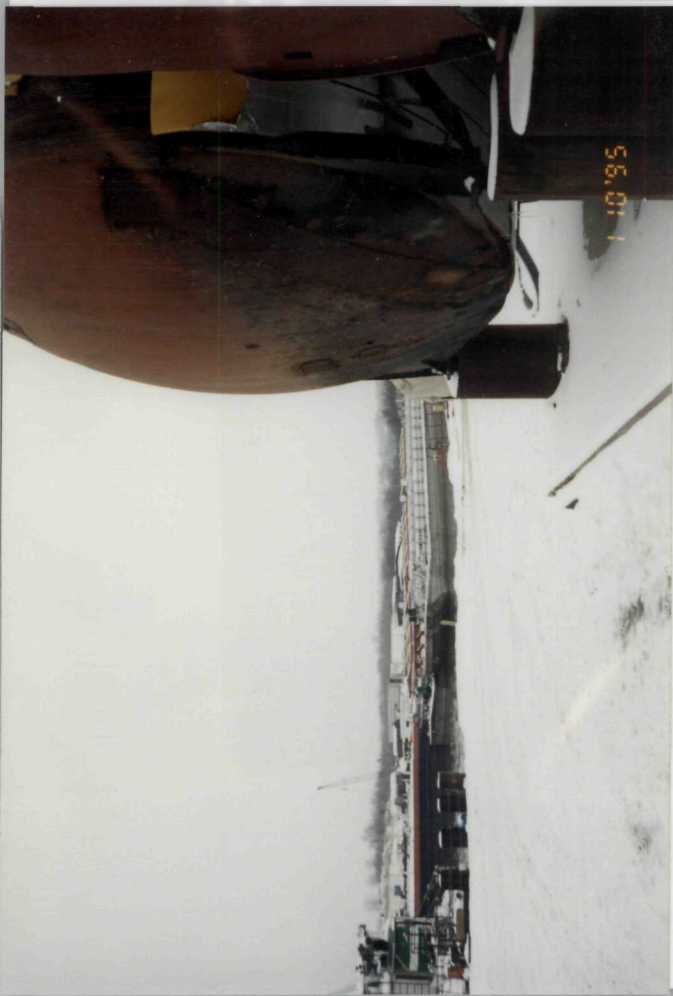
SITE: Egan Marine TDD #: T05-9501-003 DATE: 1/10/95
PHOTO #: 9 DIR: SE PHOTOGRAPHER: Rydzewski
DESCR: View showing lack of secondary containment & distance from 25,000 gallon oil tanks to canal.

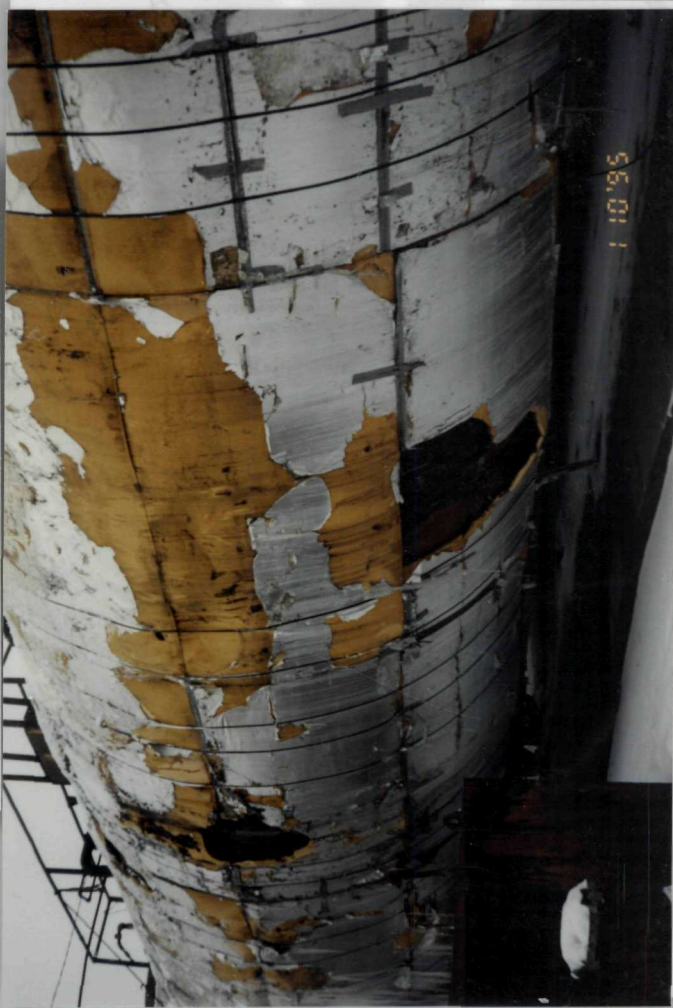
SITE: Egan Marine TDD #: T05-9501-003 DATE: 1/10/95
PHOTO #: 10 DIR: W PHOTOGRAPHER: Rydzewski
DESCR: Deteriorated condition of tank next to separator and subject of photograph #9.

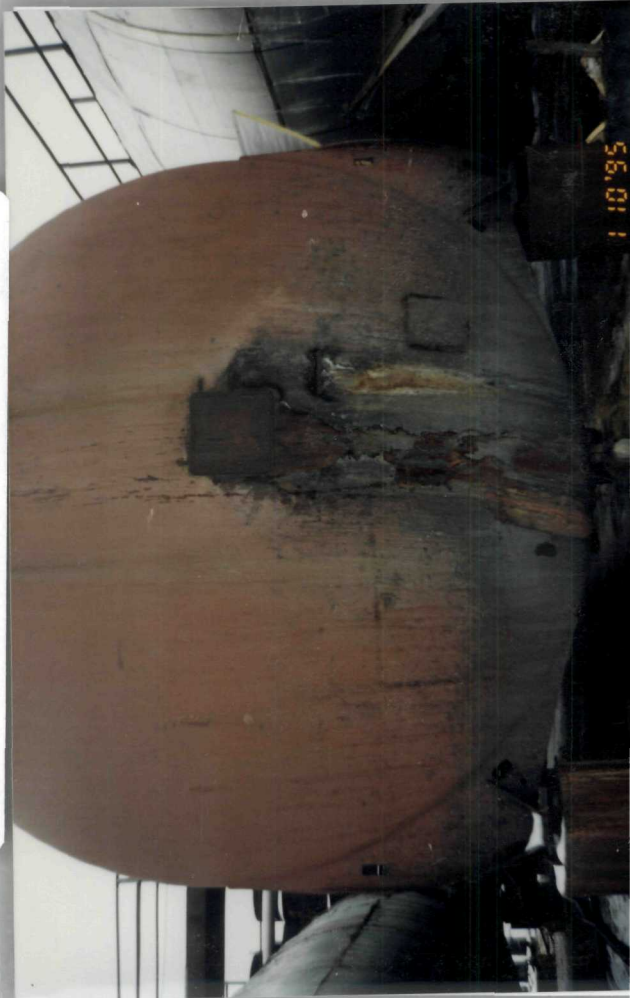
SITE: Egan Marine TDD #: T05-9501-003 DATE: 1/10/95
PHOTO #: 11 DIR: SW PHOTOGRAPHER: Rydzewski
DESCR: Deteriorated condition of vegetable oil tanks on site.

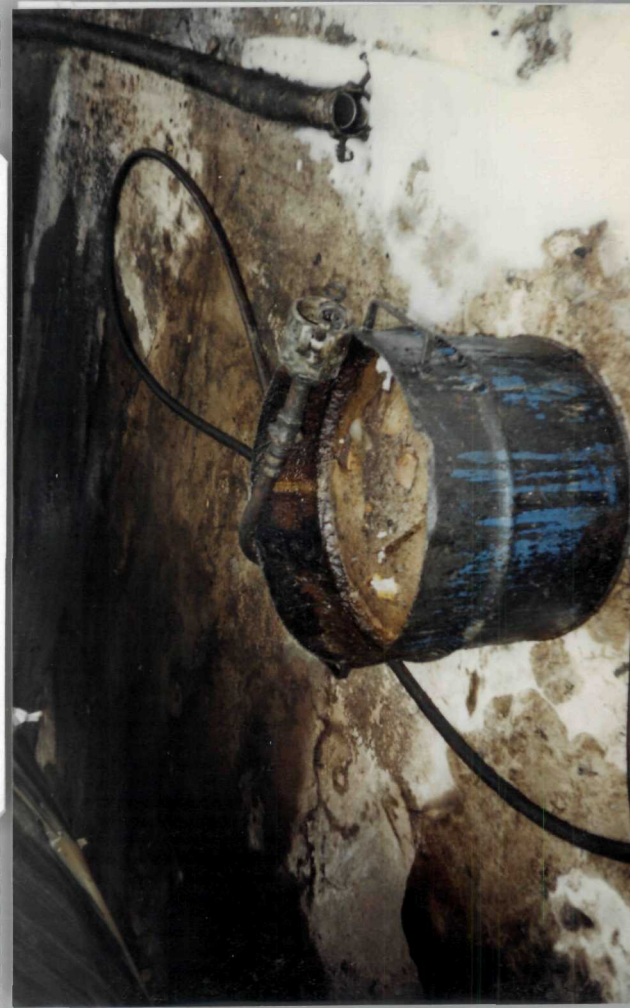
SITE: Egan Marine TDD #: T05-9501-003 DATE: 1/10/95
PHOTO #: 12 DIR: W PHOTOGRAPHER: Rydzewski
DESCR: Full drip bucket to catch oil drips when loading/unloading 25,000 gallon vegetable oil tanks.

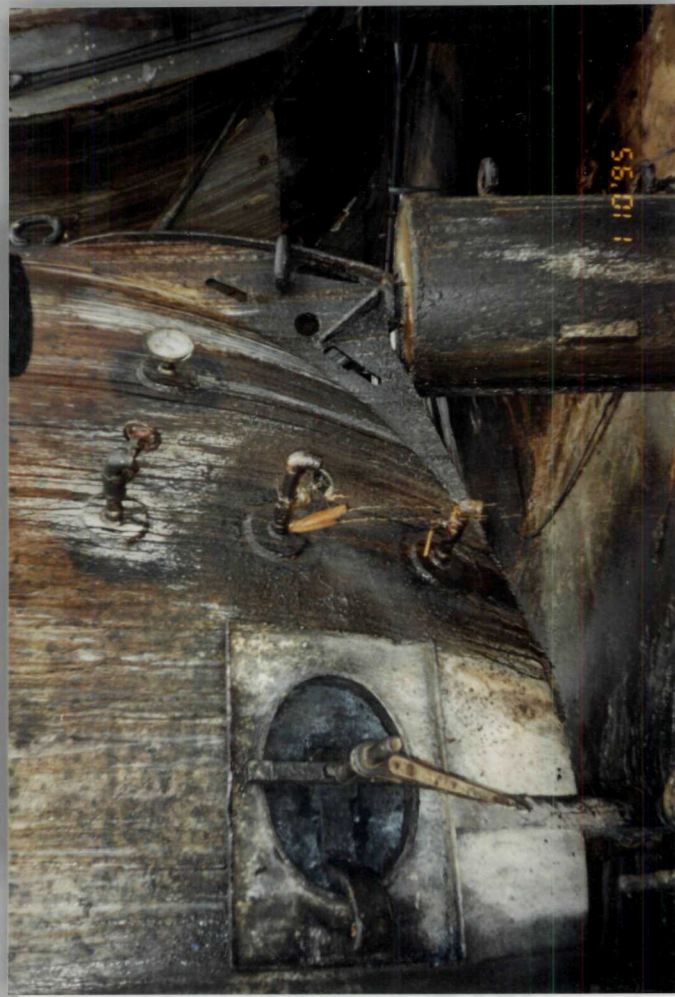
SITE: Egan Marine TDD #: T05-9501-003 DATE: 1/10/95
 PHOTO #: 14 DIR: W PHOTOGRAPHER: Rydzewski
 DESCR: Tank truck with oil spilled from its top access hatch after loading or unloading operation.

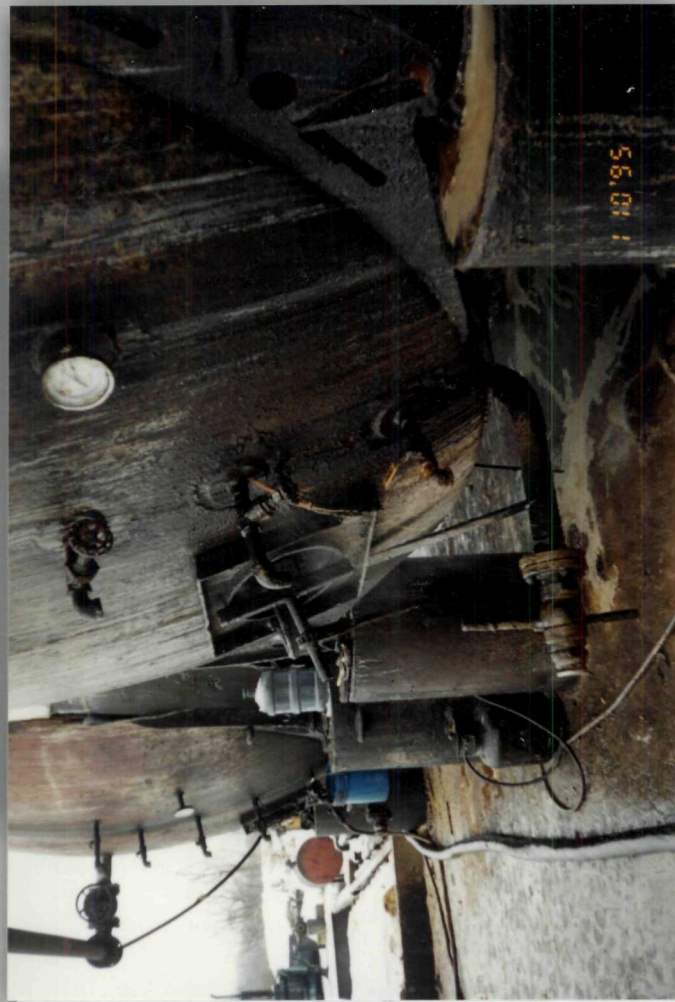
glass-lined tanks was losing a liquid in a fast flowing stream from a crack in the tank near a steam exhaust pipe. A wooden wedge was placed in the crack; however, the liquid continued to stream out of the tank. Standing oil/water was observed in the shallow pit area. Also in this area, east of the glass-lined tanks, two E-M employees were scraping oil spilled from a loading operation and placing the oil into the sludge trough. Standing puddles of oil and oil-saturated ground were present between the diesel/asphalt tanks. All tanks at the facility were in fair to poor condition and all lacked adequate secondary containment.

SITE: Egan Marine TDD #: T05-9501-003 DATE: 1/10/95
 PHOTO #: 15 DIR: NE PHOTOGRAPHER: Rydzewski
 DESCR: Wooden wedge used as a plug to stop leak from 25,000 gallon glass-lined oil tank.

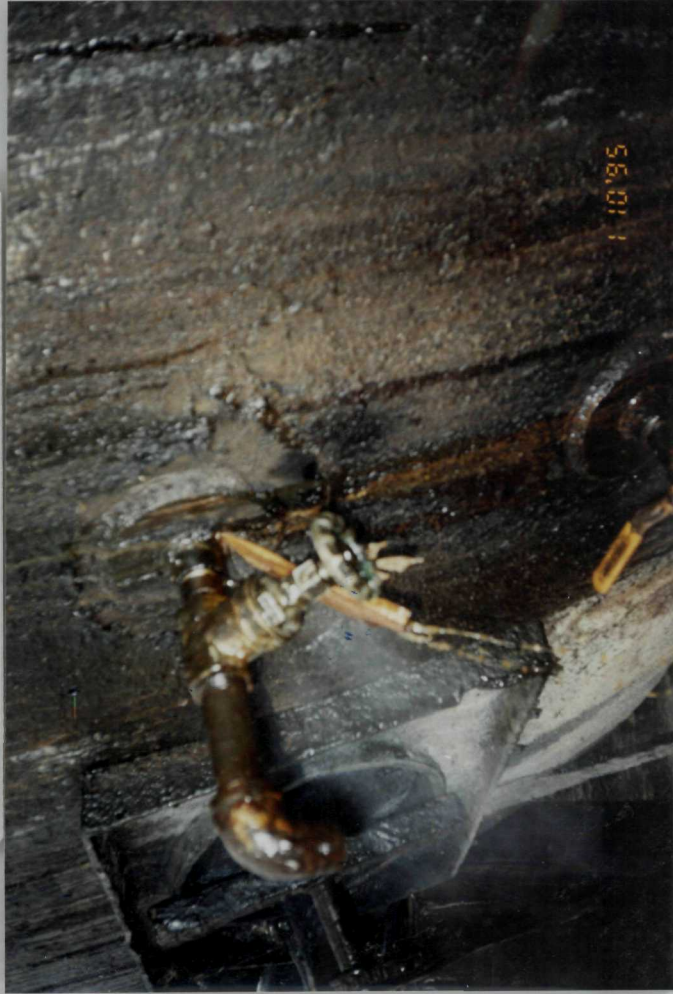
SITE: Egan Marine TDD #: T05-9501-003 DATE: 1/10/95
PHOTO #: 17 DIR: NW PHOTOGRAPHER: Rydzewski
DESCR: Close-up view of wooden wedge used to try to
plug leak of 25,000 gallon oil tank.

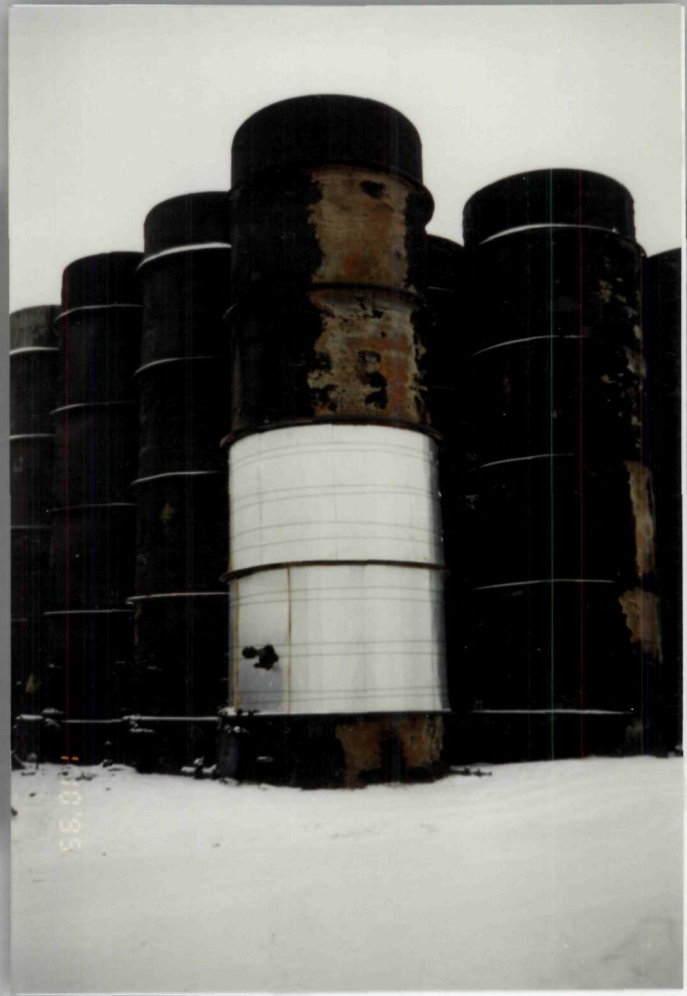
SITE: Egan Marine TDD #: T05-9501-003 DATE: 1/10/95
 PHOTO #: 22 DIR: SSE PHOTOGRAPHER: Rydzewski
 DESCR: Vegetable oil tanks which formerly were diesel oil tanks. Note tank condition and lack of berm.

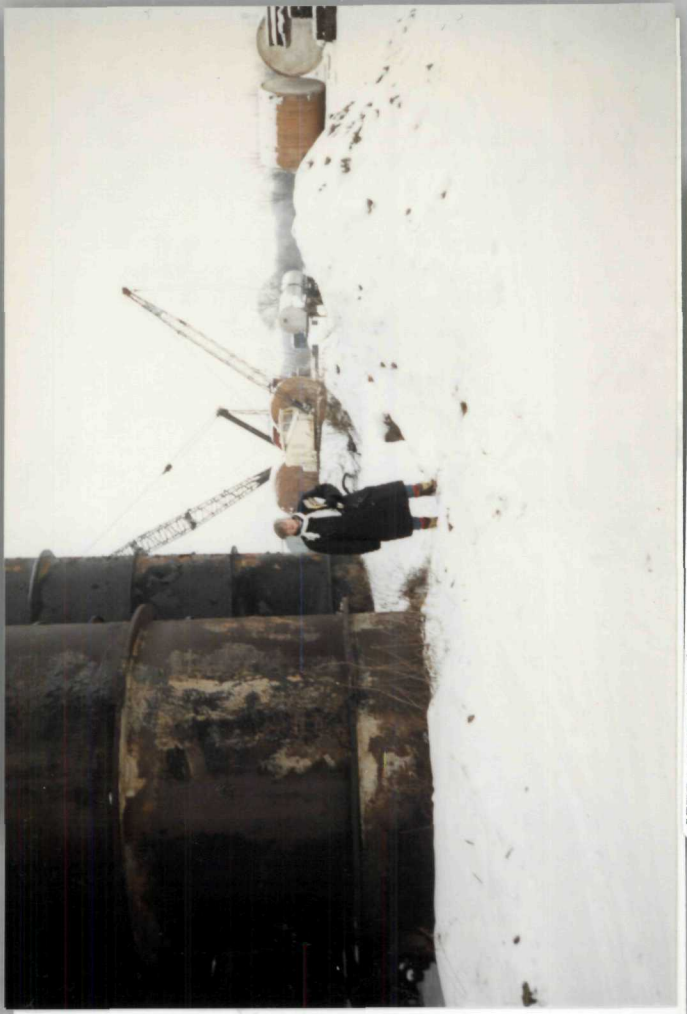
SITE: Egan Marine TDD #: T05-9501-003 DATE: 1/10/95
 PHOTO #: 23 DIR: SSE PHOTOGRAPHER: Rydzewski
 DESCR: Vegetable oil tank. Note condition of tank and lack of secondary containment.

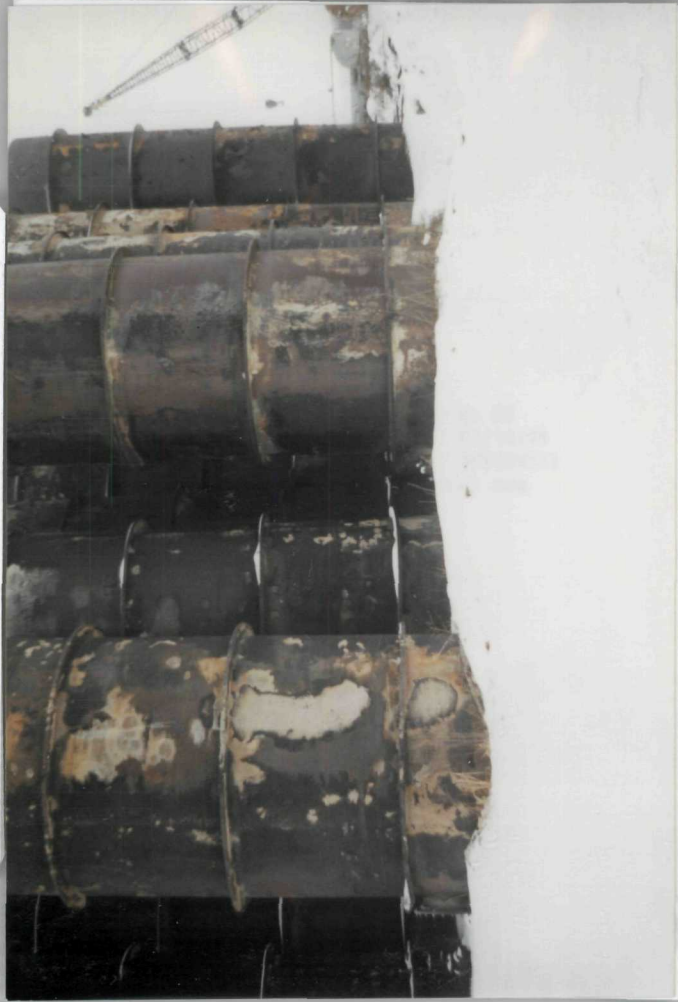
SITE: Egan Marine TDD #: T05-9501-003 DATE: 1/10/95
 PHOTO #: 25 DIR: S PHOTOGRAPHER: Rydzewski
 DESCR: Vegetable oil tanks. Note condition and lack of adequate containment.

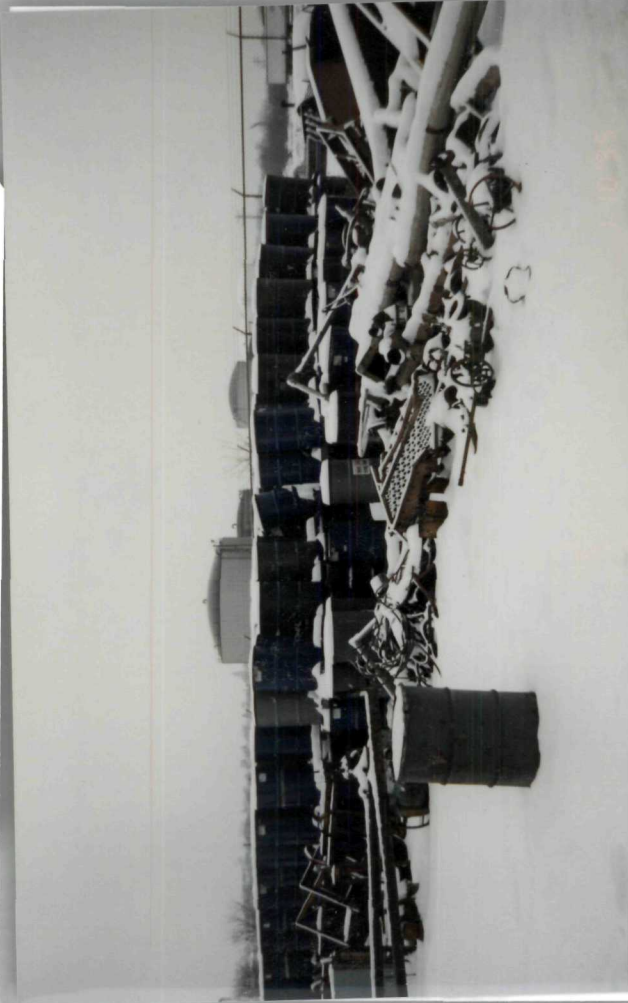
SITE: Egan Marine TDD #: T05-9501-003 DATE: 1/10/95
 PHOTO #: 27 DIR: WSW PHOTOGRAPHER: Rydzewski
 DESCR: Stacked 55-gallon drums filled with vegetable oil. There is no containment around the drums.

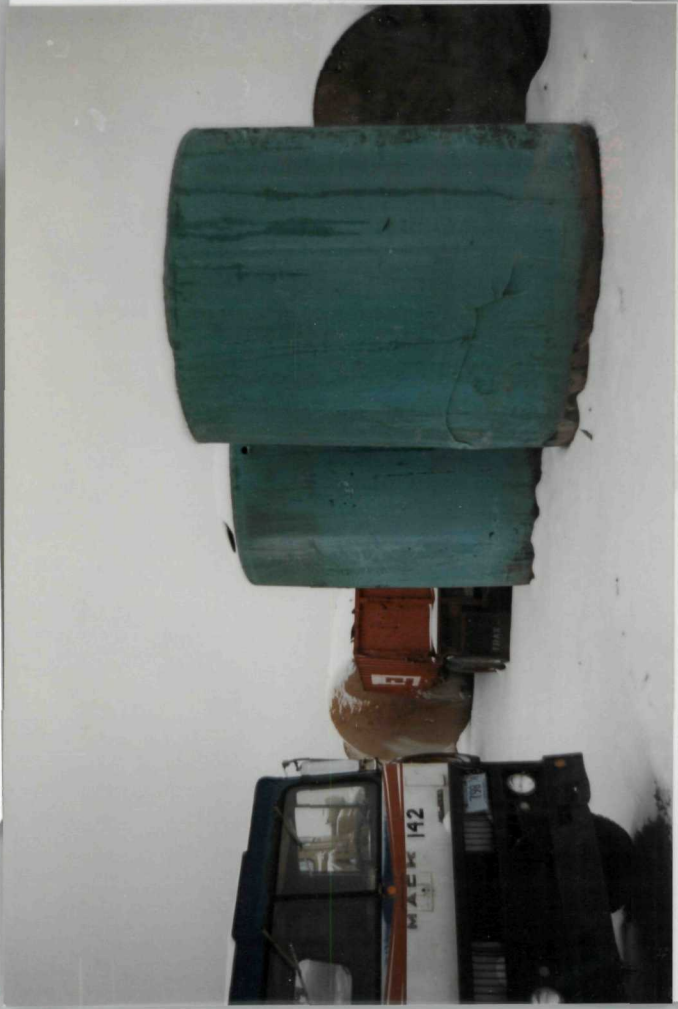
SITE: Egan Marine TDD #: T05-9501-003 DATE: 1/10/95
 PHOTO #: 26 DIR: SE PHOTOGRAPHER: Rydzewski
 DESCR: Green poly tanks on western peninsula. Note that there is no secondary containment.

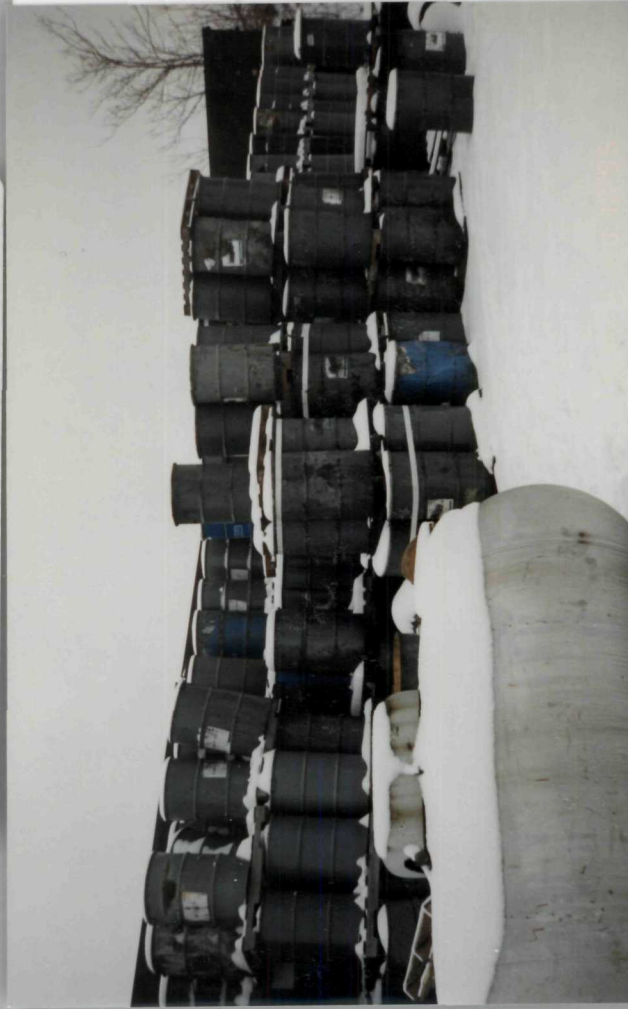
SITE: Egan Marine TDD #: T05-9501-003 DATE: 1/10/95
 PHOTO #: 28 DIR: NW PHOTOGRAPHER: Rydzewski
 DESCR: Stacked 55-gallon drums of vegetable oil with no containment. Note condition of drums.

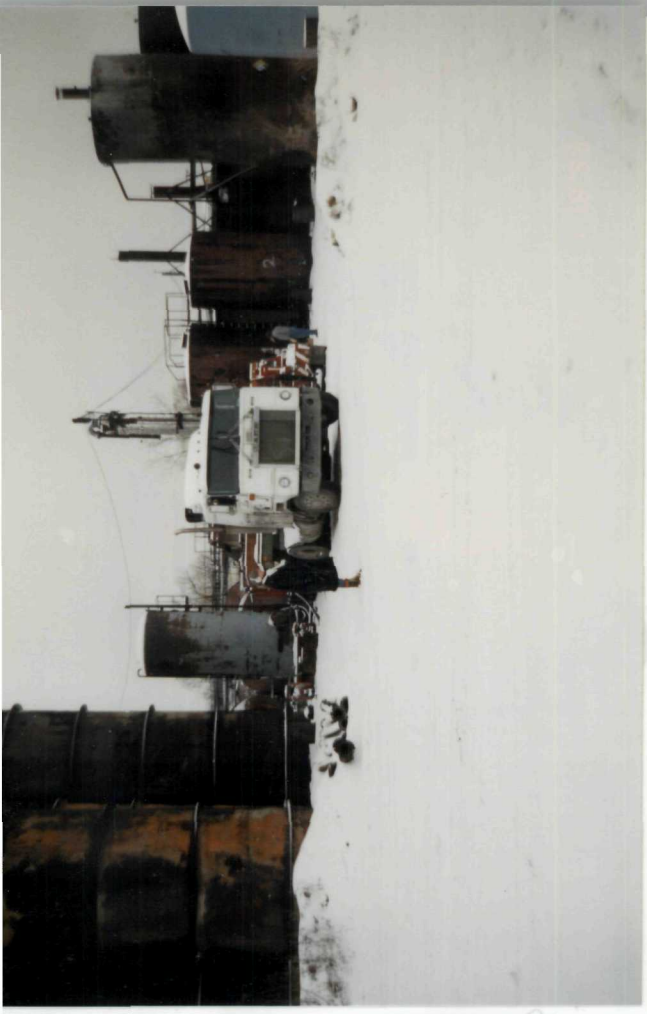
SITE: Egan Marine TDD #: T05-9501-003 DATE: 1/10/95
 PHOTO #: 31 DIR: NNE PHOTOGRAPHER: Rydzewski
 DESCR: Breach in berm near poly tanks and diesel and asphalt tanks.

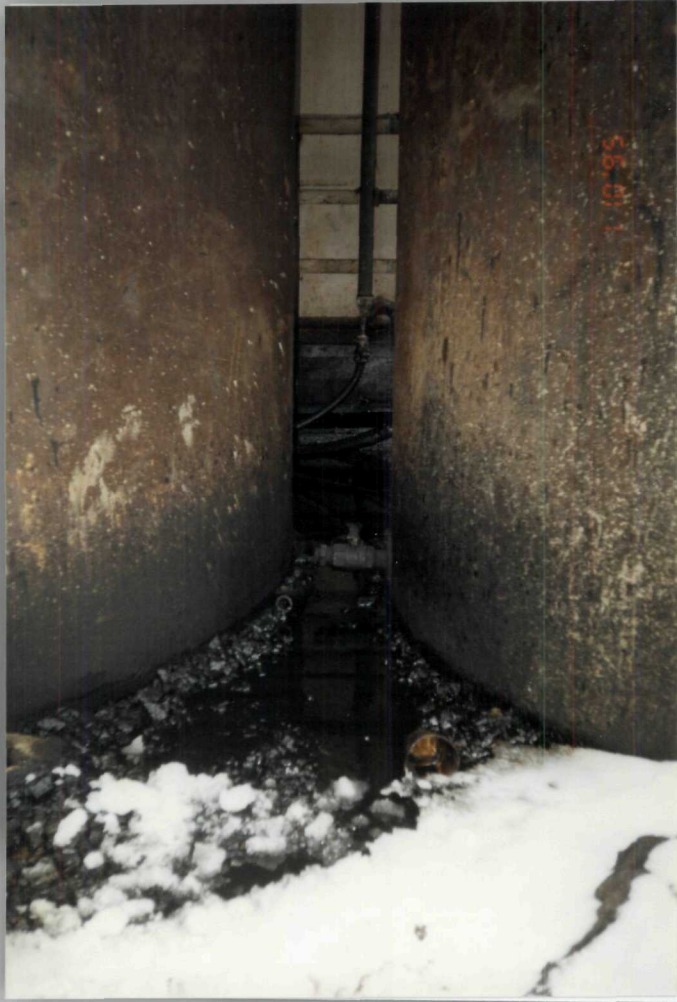
SITE: Egan Marine TDD #: T05-9501-003 DATE: 1/10/95
 PHOTO #: 32 DIR: N PHOTOGRAPHER: Rydzewski
 DESCR: Breach in berm between vegetable oil tanks and diesel and asphalt tanks.

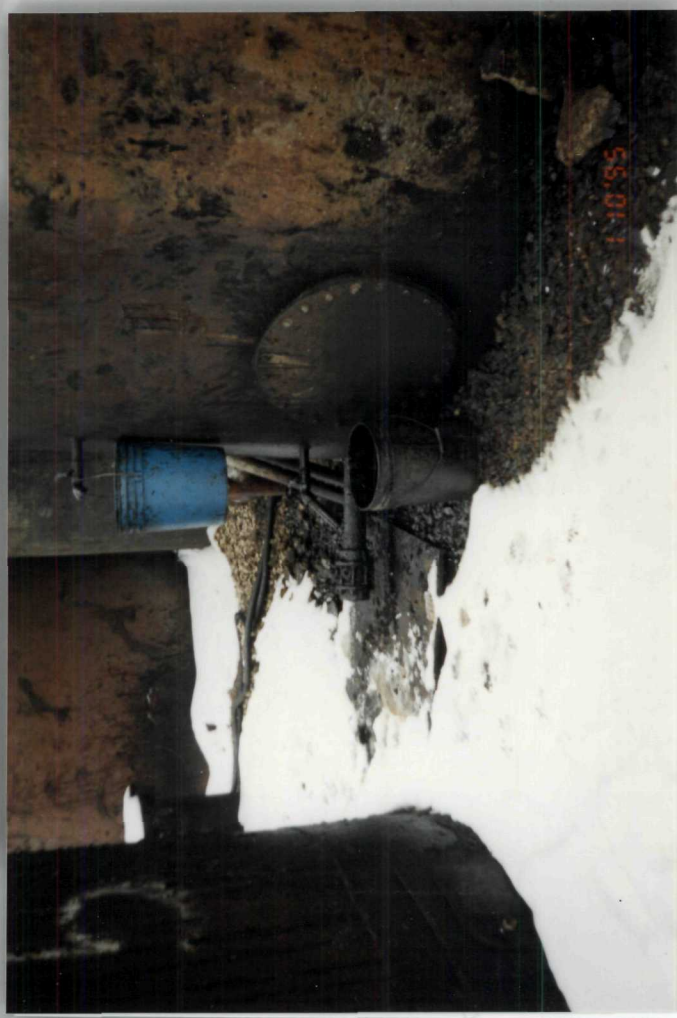
SITE: Egan Marine TDD #: T05-9501-003 DATE: 1/10/95
 PHOTO #: 33 DIR: N PHOTOGRAPHER: Rydzewski
 DESCR: Oil puddle between diesel and asphalt tanks.

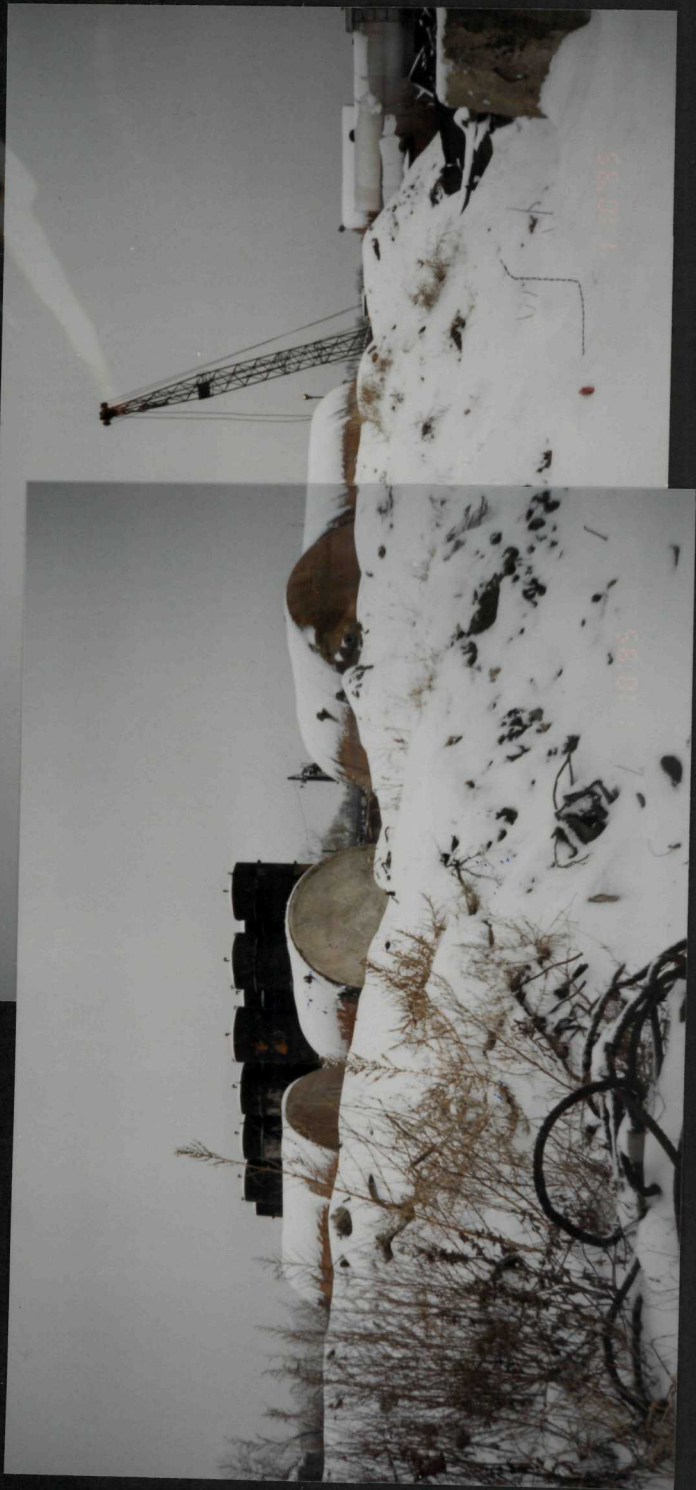
SITE: Egan Marine TDD #: T05-9501-003 DATE: 1/10/95
 PHOTO #: 34 DIR: NW PHOTOGRAPHER: Rydzewski
 DESCR: Oil-stained ground, pipes and tank. Note condition of rusted tanks.

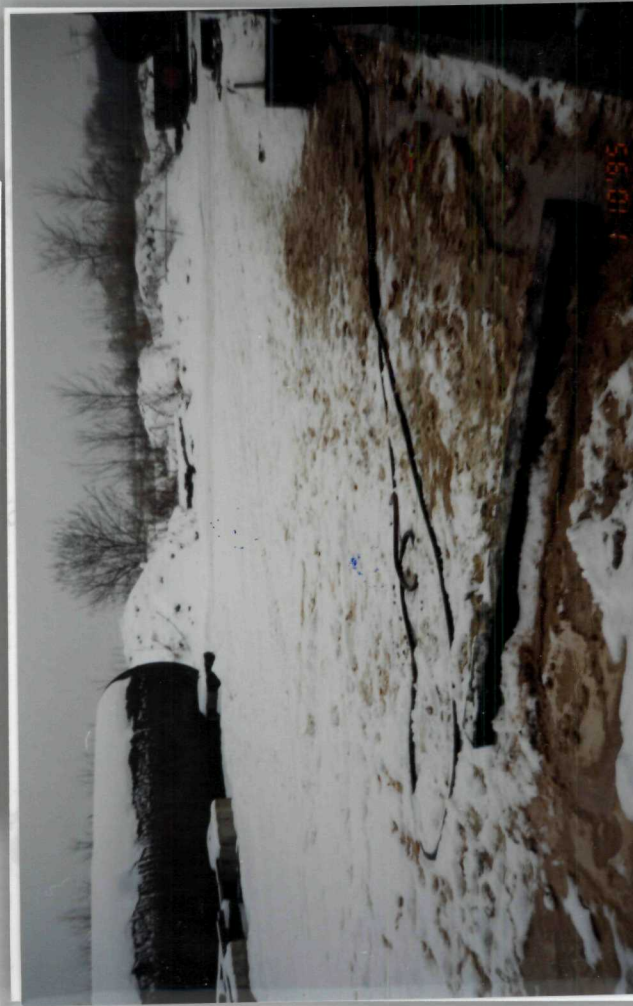
SITE: Egan Marine TDD #: T05-9501-003 DATE: 1/10/95
PHOTO #: 37 DIR: NW PHOTOGRAPHER: Rydzewski
DESCR: Solidified vegetable oil on ground next to
sludge troughs and glass-lined tanks.

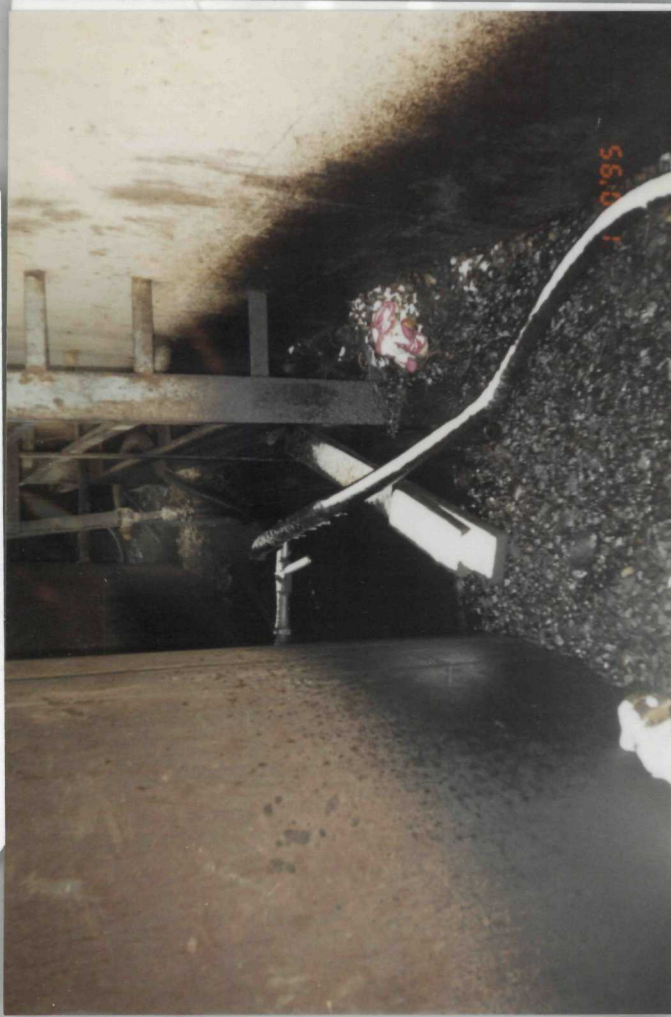
SITE: Egan Marine TDD #: T05-9501-003 DATE: 1/10/95
PHOTO #: 36 DIR: W PHOTOGRAPHER: Rydzewski
DESCR: Oil puddle between diesel and asphalt tanks
and oil-soaked ground.

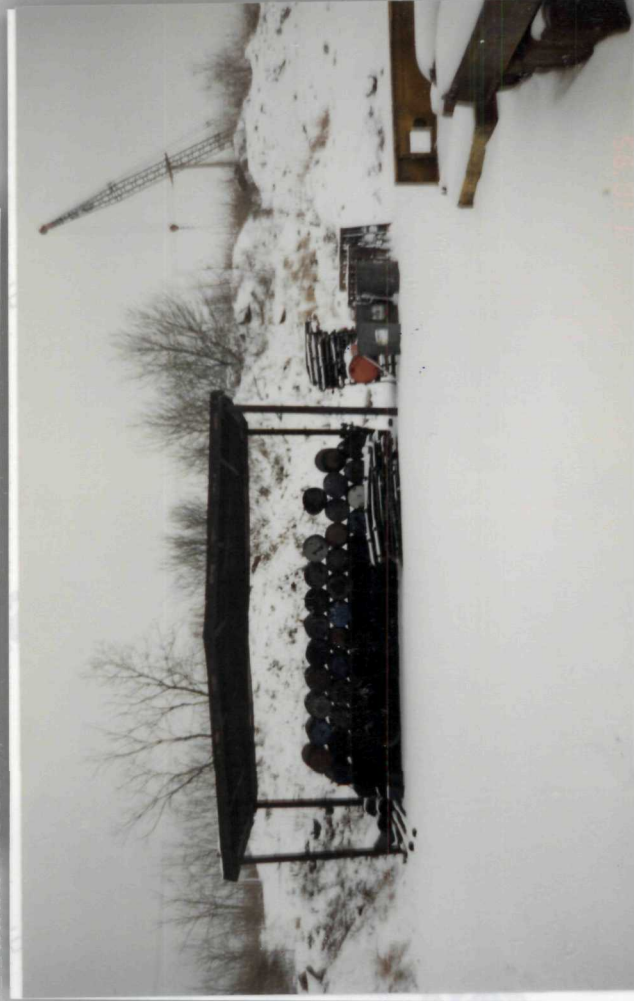
SITE: Egan Marine TDD #: T05-9501-003 DATE: 1/10/95
 PHOTO #: 45 DIR: E PHOTOGRAPHER: Rydzewski
 DESCR: Drums stored under pole shed on eastern
 peninsula. Note lack of secondary
 containment.

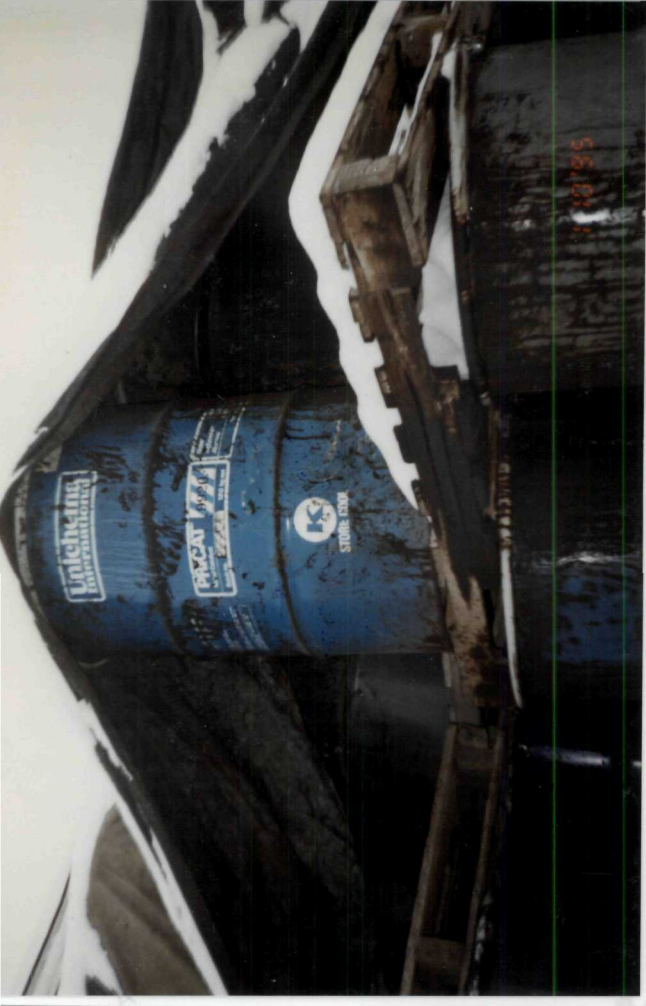
SITE: Egan Marine TDD #: T05-9501-003 DATE: 1/10/95
 PHOTO #: 47 DIR: N PHOTOGRAPHER: Rydzewski
 DESCR: Stacked 55-gallon drums of vegetable oil behind scrap storage shed. Drums have no containment.

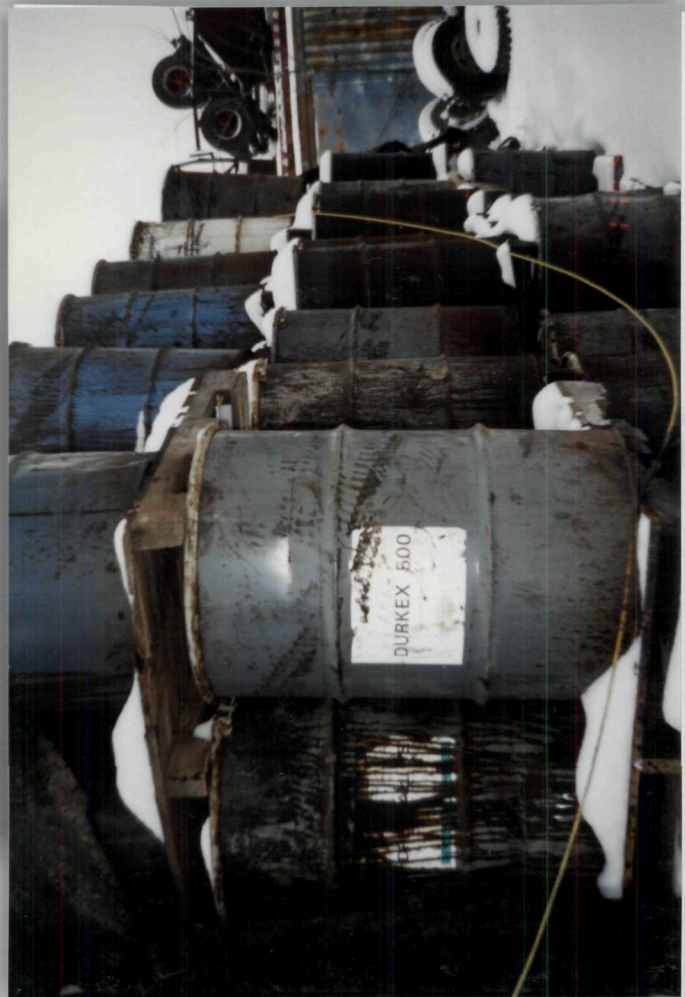
SITE: Egan Marine TDD #: T05-9501-003 DATE: 1/10/95
 PHOTO #: 48 DIR: NW PHOTOGRAPHER: Rydzewski
 DESCR: Close-up view of drums next to scrap storage shed. Note condition of drums.

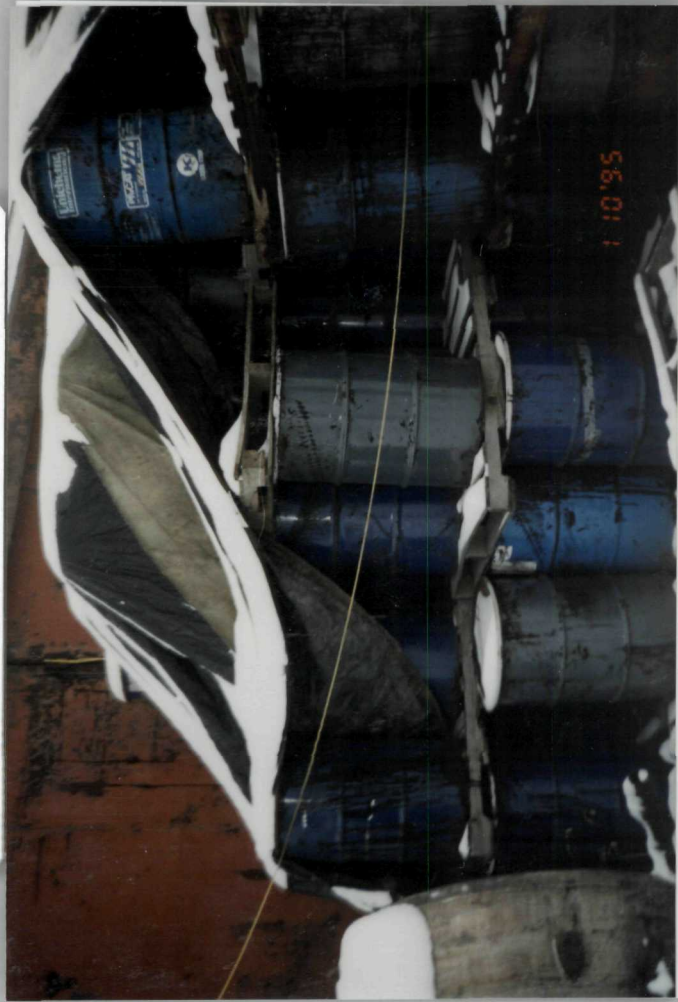
SITE: Egan Marine TDD #: T05-9501-003 DATE: 1/10/95
PHOTO #: 51 DIR: NW PHOTOGRAPHER: Rydzewski
DESCR: Drums in poor condition and stacked three high next to scrap storage shed.

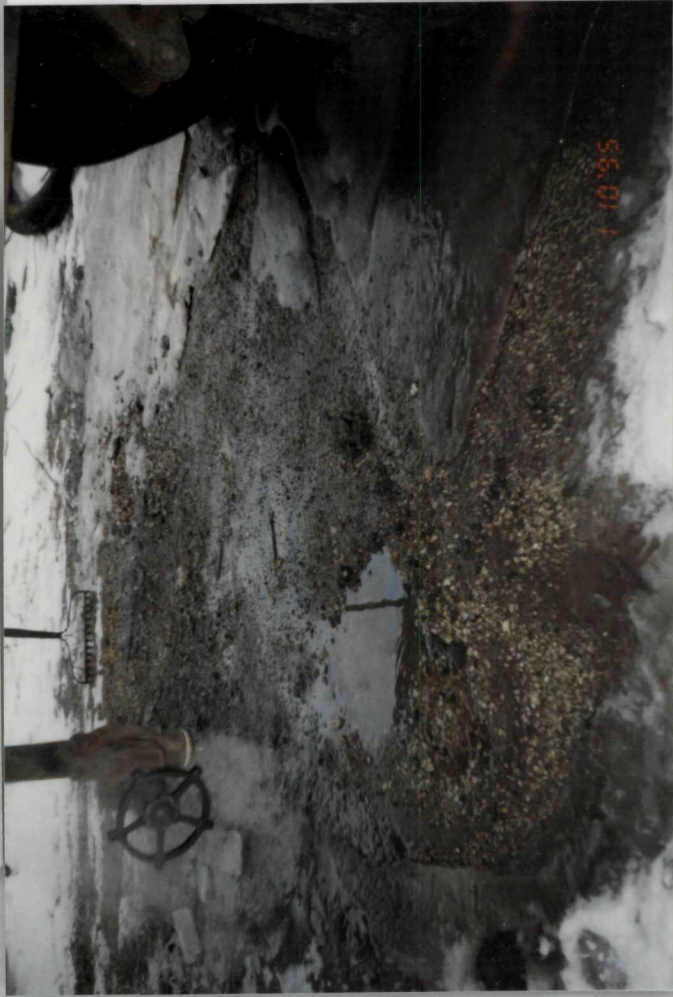
SITE: Egan Marine TDD #: T05-9501-003 DATE: 1/10/95
PHOTO #: 59 DIR: WSW PHOTOGRAPHER: Rydzewski
DESCR: View of sheen on puddle under steam exhaust
from barge-cleaning operations trailer.

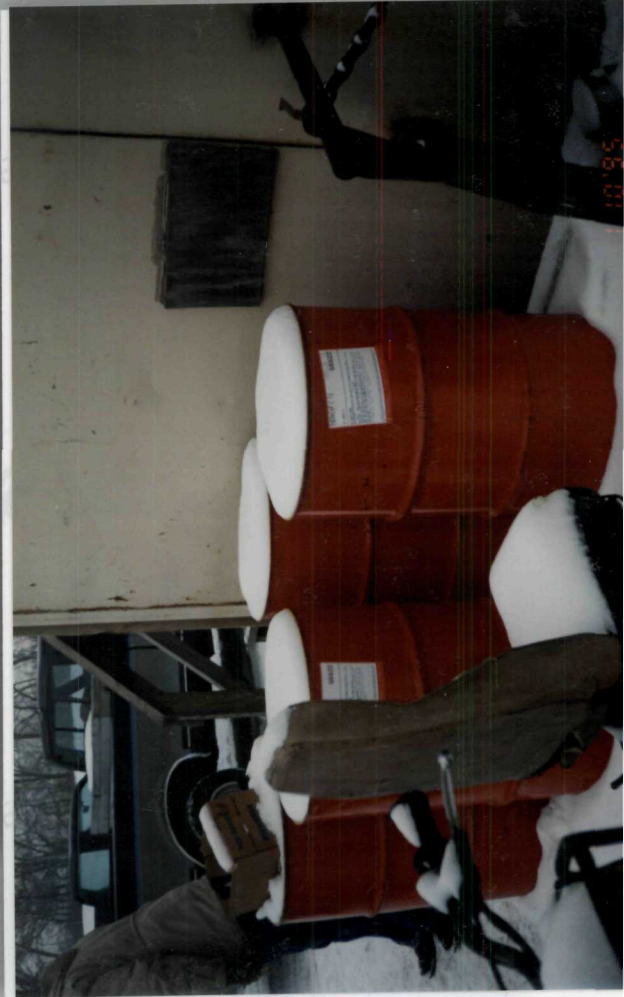
SITE: Egan Marine TDD #: T05-9501-003 DATE: 1/10/95
PHOTO #: 61 DIR: NW PHOTOGRAPHER: Rydzewski
DESCR: Drums of oil outside maintenance building.
Drums have no secondary containment.
